## FIELD INSPECTION REPORT

<b>Project Name:</b>	Mountain Valley Pipeline	<b>Inspector:</b>	Matthew Grant
<b>Inspection Date:</b>	Wednesday, September 16, 2020	<b>Project Contact:</b>	Brian Clauto
<b>Spread I: Franklin</b>	MP 264.9-265.3, 266.1-AR 265.8 ATWS 1466	<b>Weather:</b>	Dry

## FIELD INSPECTION PHOTO LOG

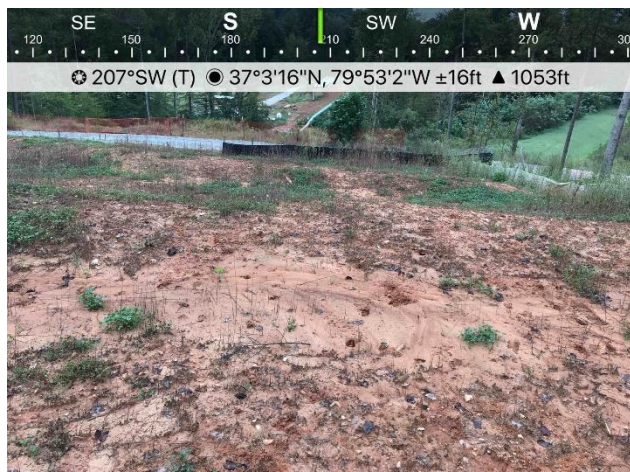
Figure 1: Waterbar requires maintenance at St14002+50

**Recommended Corrective Action:** Maintain and install all controls per the approved PSS&S.

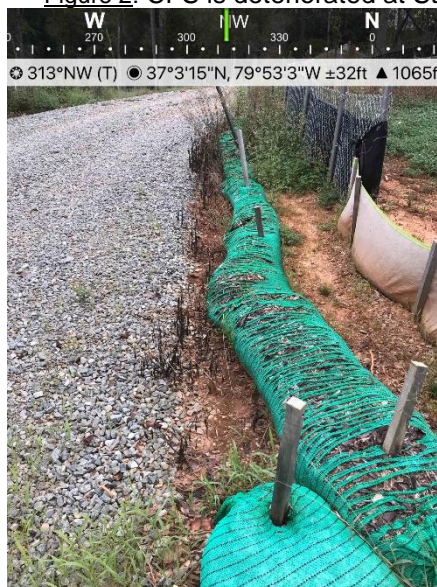
Figure 2: CFS is deteriorated at St14002+00

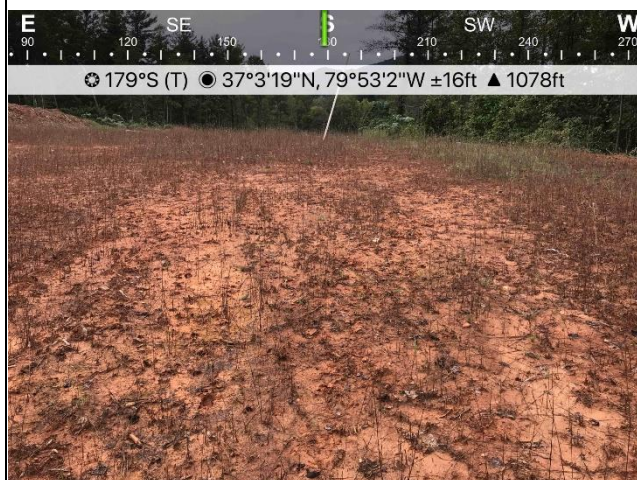
Figure 3: ROW between St13999-14009 requires additional stabilization.

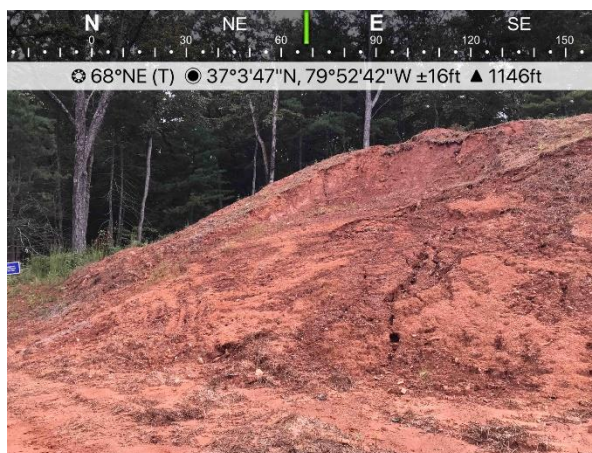
Figure 4: Stockpile requires additional stabilization at St14045
